⑥ National Dam Inspection Program. Big Piney Run Dam (Inventory Number NDS-MD-9), Ohio River Basin, Piney Creek, Garrett County, Maryland. Phase I Inspection Report.

BIG PNEY RUN DAM

## PHASE I INSPECTION REPORT

by  
BERGER ASSOCIATES, INC  
CONSULTING ENGINEERS  
HARRISBURG, PA.

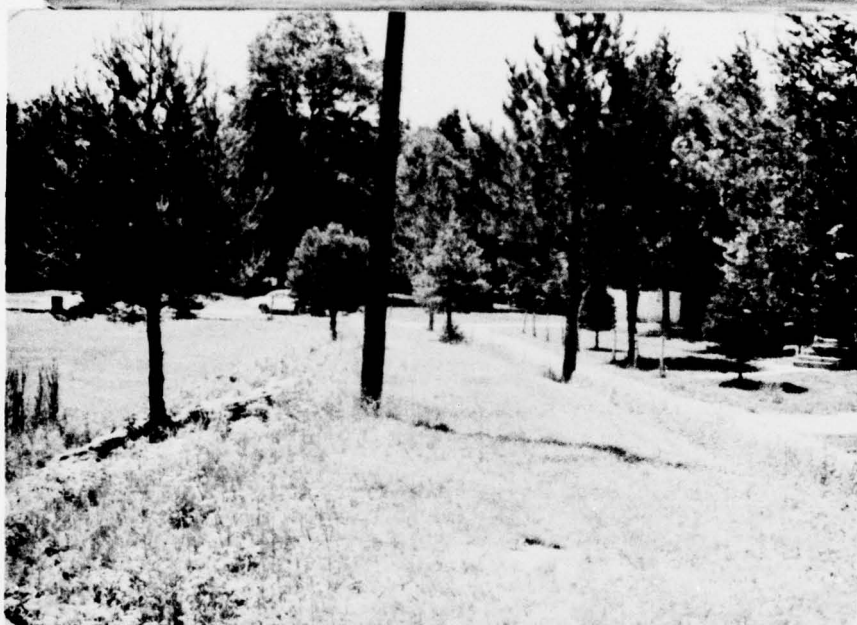
This low but relatively long earthfill abutment was in good condition. No signs of sloughing were detected and no seepage was noticed. Some trees were growing on the embankment, but the presence of a concrete core wall, the small height of the embankment and the relatively flat area downstream of this embankment makes these trees less objectionable. Adjacent to the first buttress wall the embankment crest has a depression for a length of 20 feet with a maximum depth of 15 inches.

Embankment  
Left Abutment  
(South)

1. The owner shall backfill the low area on the embankment adjacent to the first buttress wall immediately.
2. The owner shall monitor the leakage through the joints in the slab and buttresses. If leakage increases, corrective measurements shall be taken to prevent serious damage to the structure.
3. The owner shall remove the trees growing on the embankment.

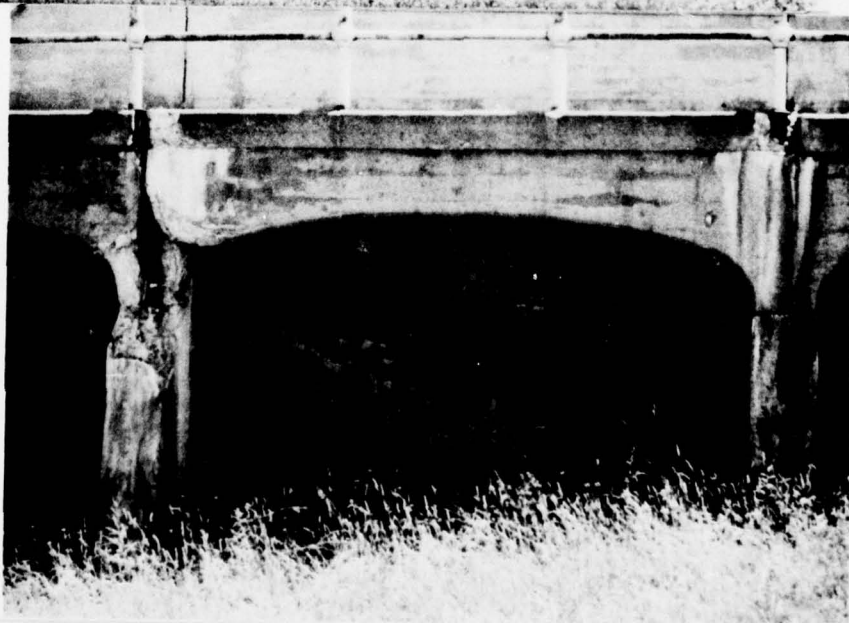
Some of the arched struts on the downstream side, located below the sidewalk, showed serious deterioration. Although the visual impression is unpleasant, these arches are not an important structural part of the dam.

All buttresses appeared to be in good condition, except one corbel in the third bay from the spillway. This corbel had deteriorated considerably over several feet length. Most of the buttress walls and concrete slabs could not be observed because approximately two-thirds of the height is underground.

Buttress &  
Arch Strut

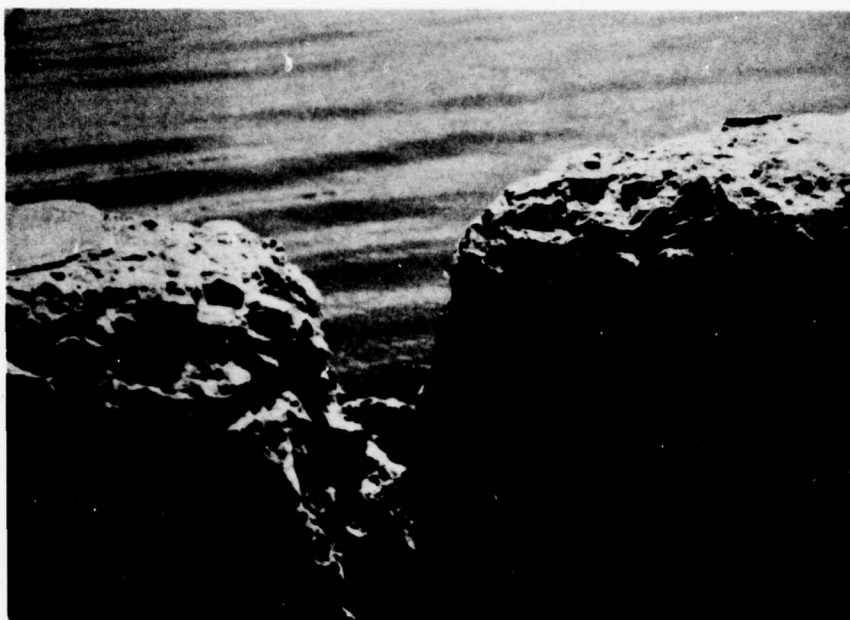
Several light posts were installed on top of the parapet wall. The type of construction used for anchoring these light posts deteriorated the concrete and some deep gaps are in the parapet wall (Plate V, Appendix D). However the water coming through these gaps would not endanger the structure.

Parapet at  
Light Post

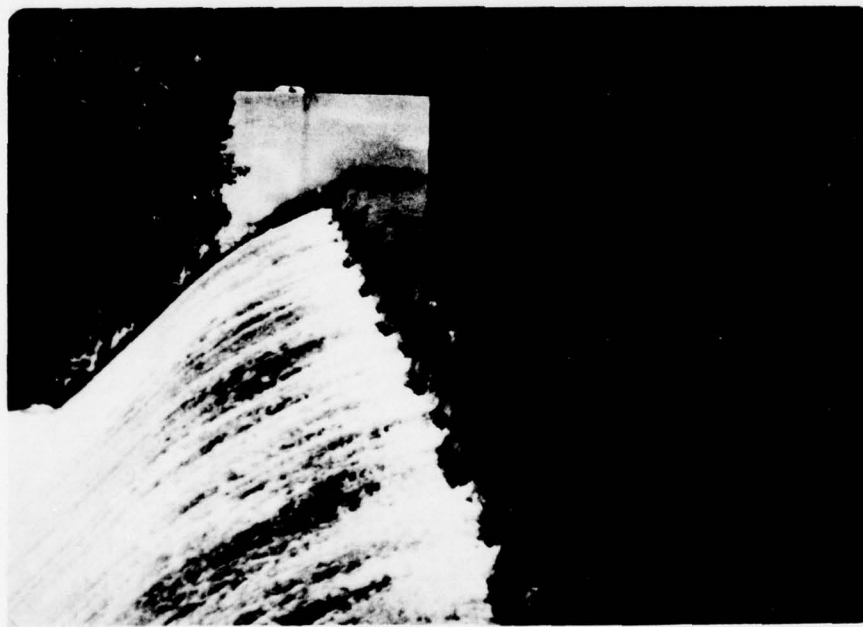
The spillway overflow section is an integral part of the buttress dam. At the time of inspection the pool level was approximately 5 inches above the top of flashboards and a close inspection of the spillway surface was not feasible. Some deterioration of the ogee section was apparent and the joint between the spillway and abutment walls should be investigated. A keyed joint in the downstream right wingwall was heavily damaged, but does not appear to affect the safety of the structure. The damage is caused by difference in deflection and the outside part of the female key is sheared off.

During the inspection the spillway discharged approximately five inches over the flashboards and close inspection was not feasible. It appears that some deterioration of concrete has occurred on the downstream face of the ogee section. The joints between the ogee and the abutment needs some repair. The spalling of the expansion joint in the downstream wingwall does not affect the structural stability. The intake tower appeared to be in satisfactory condition.

Spillway & Flashboards
